# MINNESOTA HISTORIC PROPERTY RECORD

## INDEX TO PHOTOGRAPHS

Mn/DOT BRIDGE 9800

(LAFAYETTE BRIDGE)

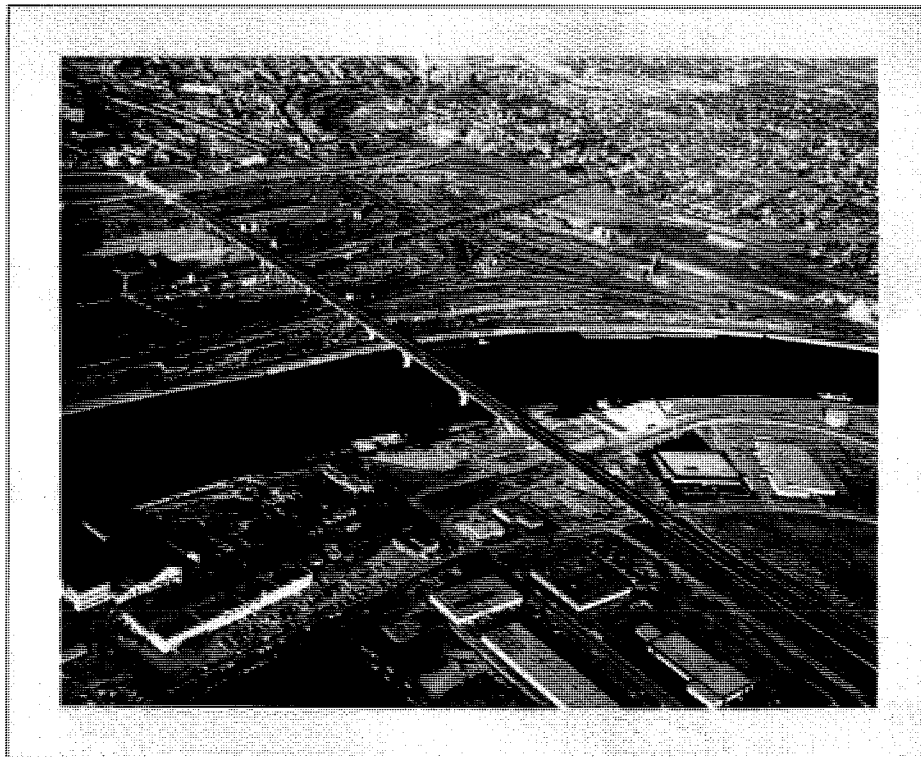
MHPR No. RA-SPC-7891-01

| RA-SPC-7891-01 | AERIAL CONTEXT VIEW OF BRIDGE 9800, LOOKING NORTHEAST. HISTORICAL PHOTOGRAPH DATED DECEMBER 11, 1968. MHS REFERENCE LIBRARY LOCATOR 107.I.2.8F-1 BOX 6 9800, ENVELOPE 4, MINNESOTA HIGHWAY DEPARTMENT, BRIDGE DIVISION, BRIDGE PHOTOGRAPHS AND NEGATIVES, MHS, STATE ARCHIVES. |

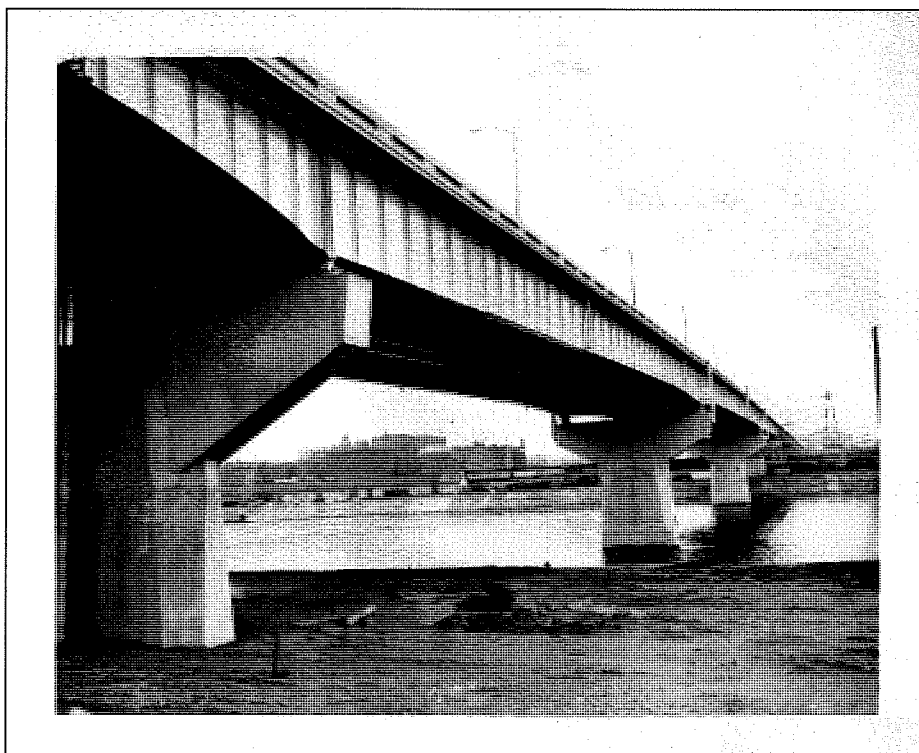
MHPR No. RA-SPC-7891-02

| RA-SPC-7891-02 | OBLIQUE VIEW OF SOUTH ELEVATION OF SPAN 11, SHOWING PIERS 11, 10, AND 9 (LEFT TO RIGHT), LOOKING SOUTH-SOUTHEAST. HISTORICAL PHOTOGRAPH DATED DECEMBER 11, 1968. MHS REFERENCE LIBRARY LOCATOR 107.I.2.8F-1 BOX 6 9800, ENVELOPE 3, MINNESOTA HIGHWAY DEPARTMENT, BRIDGE DIVISION, BRIDGE PHOTOGRAPHS AND NEGATIVES, MHS, STATE ARCHIVES. |

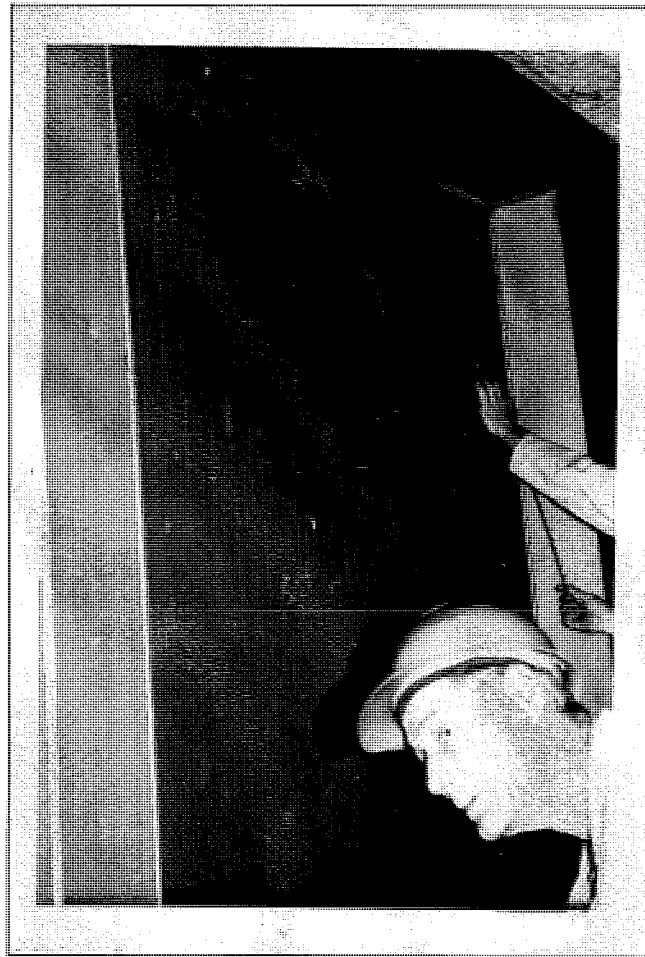
MHPR No. RA-SPC-7891-04

- RA-SPC-7891-04      VIEW OF UPPER PORTION OF SPAN 10 GIRDER FRACTURE, SHOWING BUCKLING OF GIRDER WEB PLATE, LOOKING NORTHWEST. HISTORICAL PHOTOGRAPH DATED JULY, 1975. MHS REFERENCE LIBRARY LOCATOR 107.I.2.8F-1 BOX 6 9800, ENVELOPE 2, MINNESOTA HIGHWAY DEPARTMENT, BRIDGE DIVISION, BRIDGE PHOTOGRAPHS AND NEGATIVES, MHS, STATE ARCHIVES.

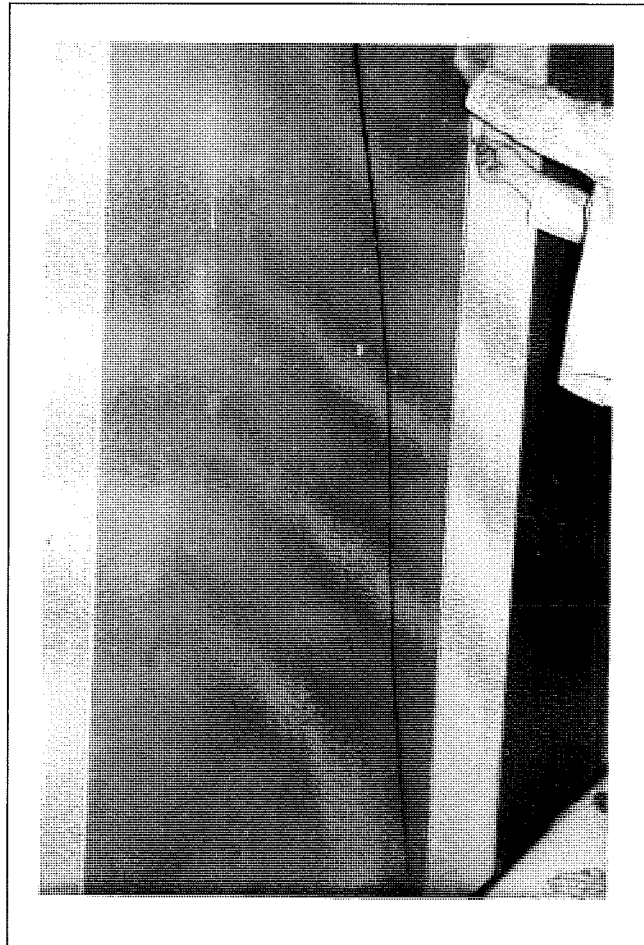
MHPR No. RA-SPC-7891-05

- RA-SPC-7891-05      VIEW OF LOWER PORTION OF SPAN 10 GIRDER FRACTURE, LOOKING NORTHWEST. HISTORICAL PHOTOGRAPH DATED JULY, 1975. MHS REFERENCE LIBRARY LOCATOR 107.I.2.8F-1 BOX 6 9800, ENVELOPE 1, MINNESOTA HIGHWAY DEPARTMENT, BRIDGE DIVISION, BRIDGE PHOTOGRAPHS AND NEGATIVES, MHS, STATE ARCHIVES.

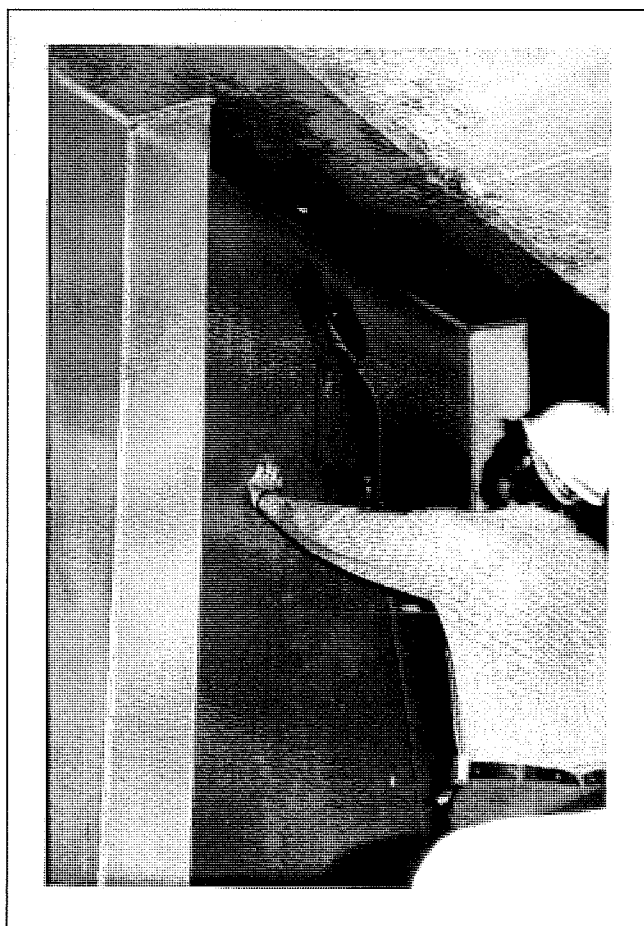
MHPR No. RA-SPC-7891-06

- RA-SPC-7891-06      VIEW OF UPPER PORTION OF SPAN 10 GIRDER FRACTURE, SHOWING BUCKLING OF GIRDER WEB PLATE, LOOKING NORTHWEST. HISTORICAL PHOTOGRAPH DATED JULY, 1975. MHS REFERENCE LIBRARY LOCATOR 107.I.2.8F-1 BOX 6 9800, ENVELOPE 1, MINNESOTA HIGHWAY DEPARTMENT, BRIDGE DIVISION, BRIDGE PHOTOGRAPHS AND NEGATIVES, MHS, STATE ARCHIVES.

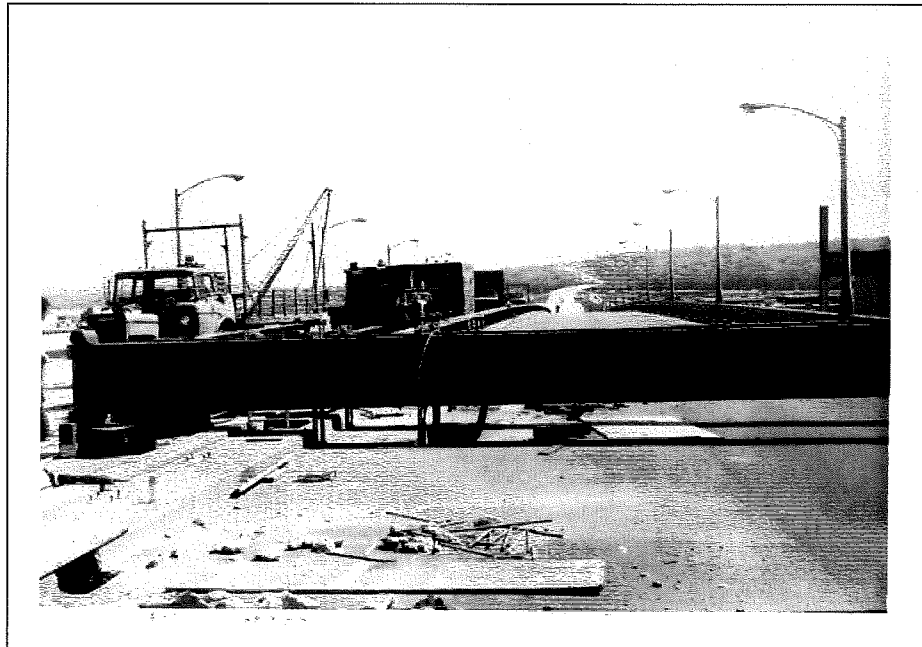
MHPR No. RA-SPC-7891-07

- RA-SPC-7891-07      VIEW OF FRACTURE REPAIR PROCESS, LOOKING SOUTH. HISTORICAL PHOTOGRAPH DATED JULY, 1975. MHS REFERENCE LIBRARY LOCATOR 107.I.2.8F-1 BOX 6 9800, ENVELOPE 3, MINNESOTA HIGHWAY DEPARTMENT, BRIDGE DIVISION, BRIDGE PHOTOGRAPHS AND NEGATIVES, MHS, STATE ARCHIVES.

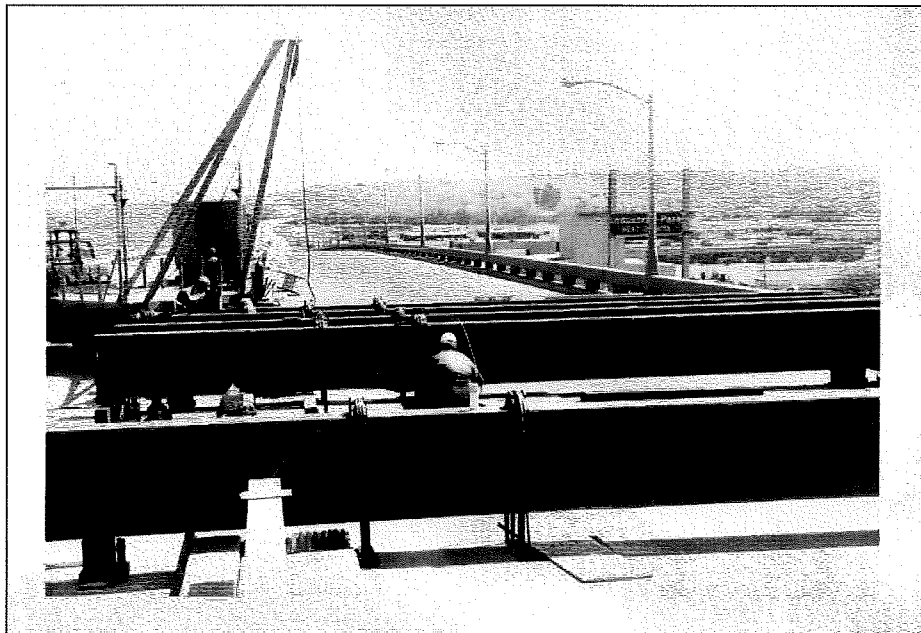
MHPR No. RA-SPC-7891-08

- RA-SPC-7891-08      VIEW OF FRACTURE REPAIR PROCESS, LOOKING SOUTH. HISTORICAL PHOTOGRAPH DATED JULY, 1975. MHS REFERENCE LIBRARY LOCATOR 107.I.2.8F-1 BOX 6 9800, ENVELOPE 1, MINNESOTA HIGHWAY DEPARTMENT, BRIDGE DIVISION, BRIDGE PHOTOGRAPHS AND NEGATIVES, MHS, STATE ARCHIVES.

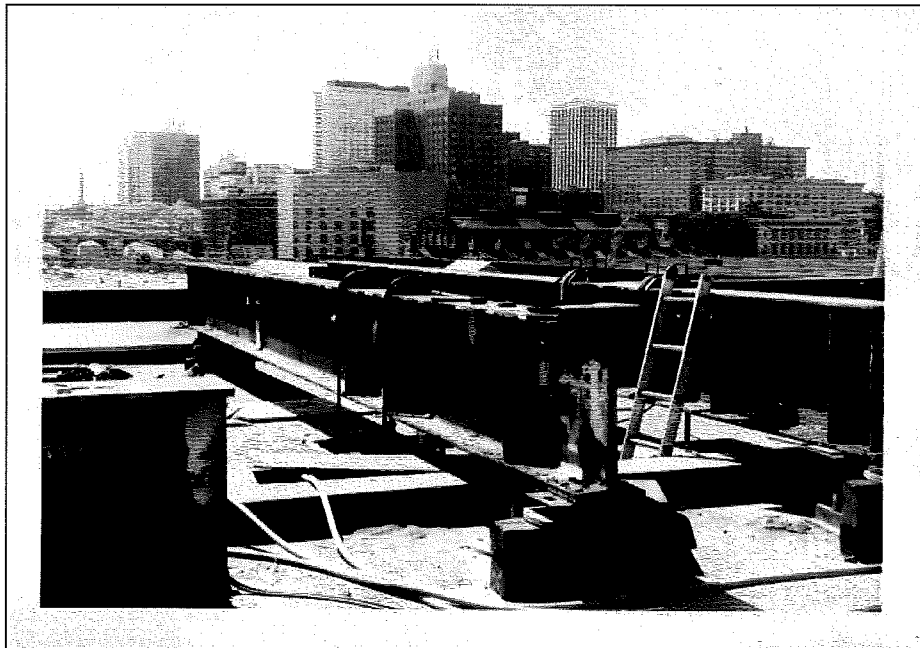
MHPR No. RA-SPC-7891-09

- RA-SPC-7891-09      VIEW OF FRACTURE REPAIR PROCESS, LOOKING NORTHWEST TOWARDS DOWNTOWN SAINT PAUL. HISTORICAL PHOTOGRAPH DATED JULY, 1975. MHS REFERENCE LIBRARY LOCATOR 107.I.2.8F-1 BOX 6 9800, ENVELOPE 2, MINNESOTA HIGHWAY DEPARTMENT, BRIDGE DIVISION, BRIDGE PHOTOGRAPHS AND NEGATIVES, MHS, STATE ARCHIVES.

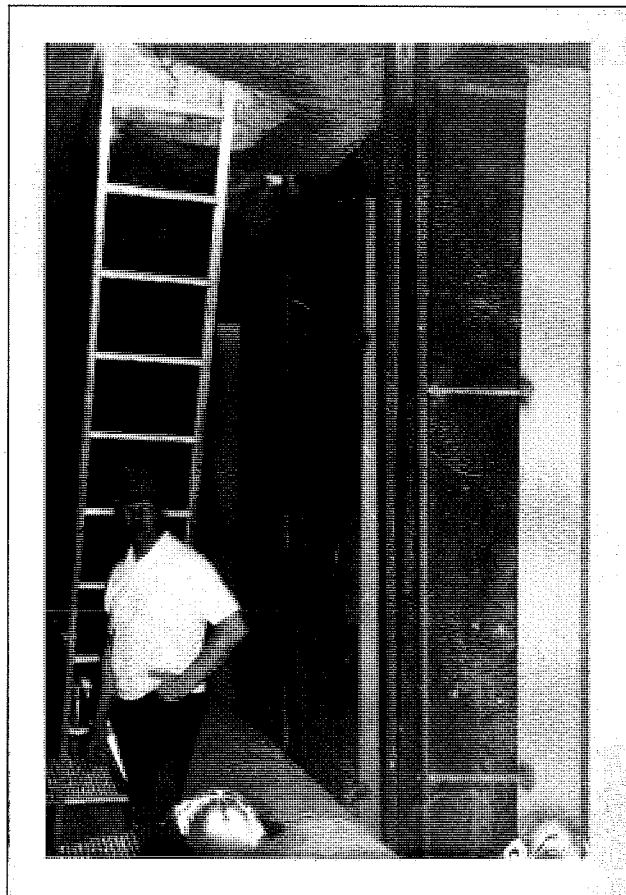
MHPR No. RA-SPC-7891-10

- RA-SPC-7891-10 VIEW OF FRACTURE REPAIR PROCESS FROM INSIDE SERVICE CATWALK, LOOKING SOUTHEAST. HISTORICAL PHOTOGRAPH DATED JULY, 1975. MHS REFERENCE LIBRARY LOCATOR 107.I.2.8F-1 BOX 6 9800, ENVELOPE 1, MINNESOTA HIGHWAY DEPARTMENT, BRIDGE DIVISION, BRIDGE PHOTOGRAPHS AND NEGATIVES, MHS, STATE ARCHIVES.

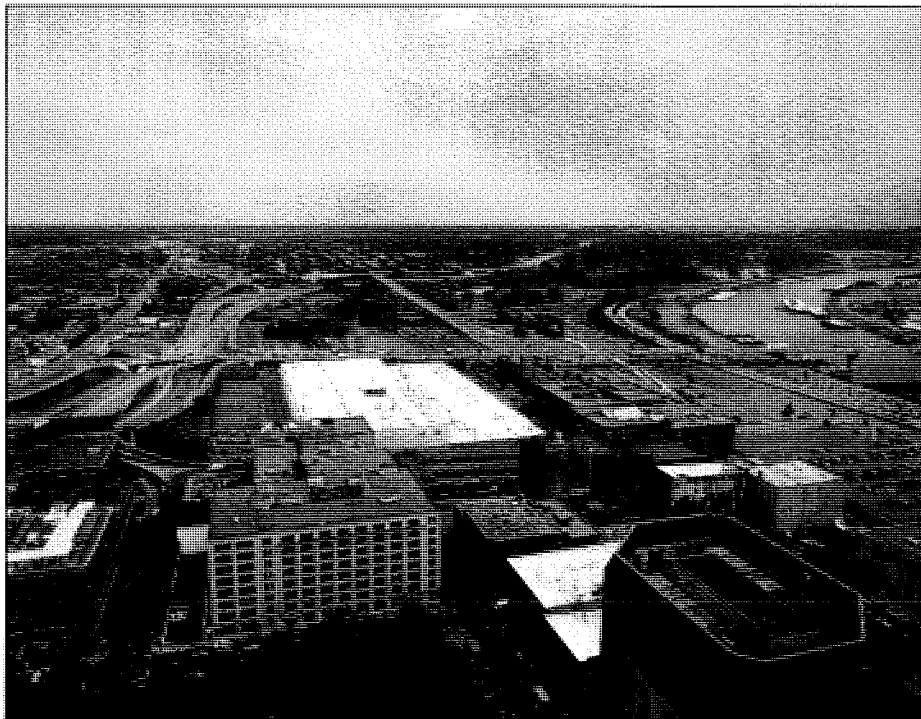
MHPR No. RA-SPC-7891-11

- RA-SPC-7891-11 CONTEXT VIEW OF NORTH PORTION OF BRIDGE (CENTER OF SPAN 10 – SPAN 29), SHOWING CONNECTIONS TO INTERSTATE 94. LOOKING EAST FROM GALTIER TOWER, SAINT PAUL.

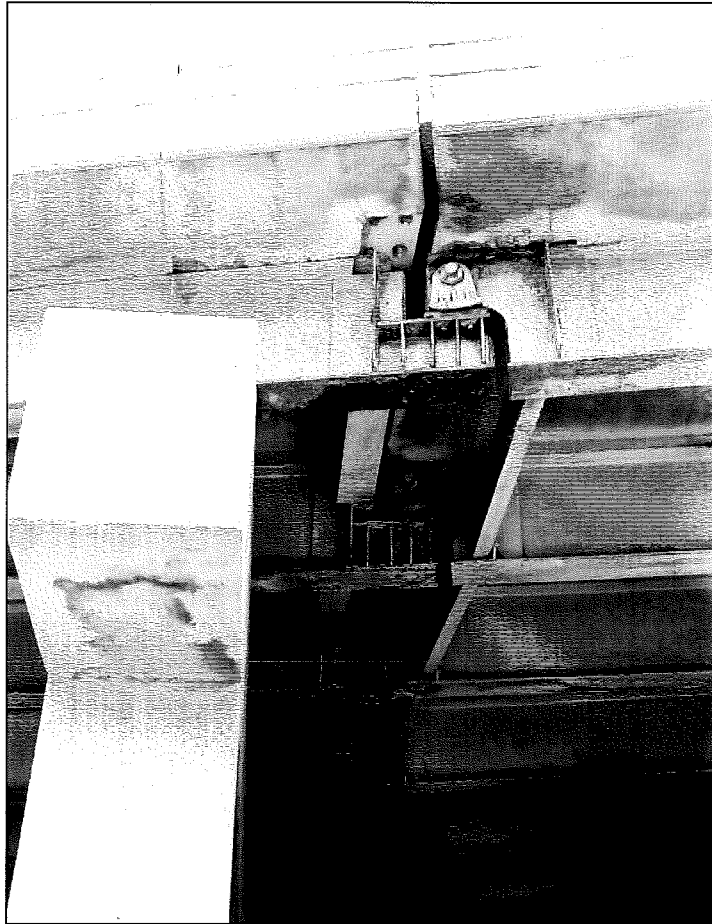
MHPR No. RA-SPC-7891-16

- RA-SPC-7891-16 VIEW OF HINGES IN SPAN 28 AT PIER 28, LOOKING EAST-NORTHEAST.
- RA-SPC-7891-17 VIEW OF BRIDGE PIERS AND DECK SYSTEM, LOOKING NORTHWEST FROM SPAN 16 AND PIER 17.

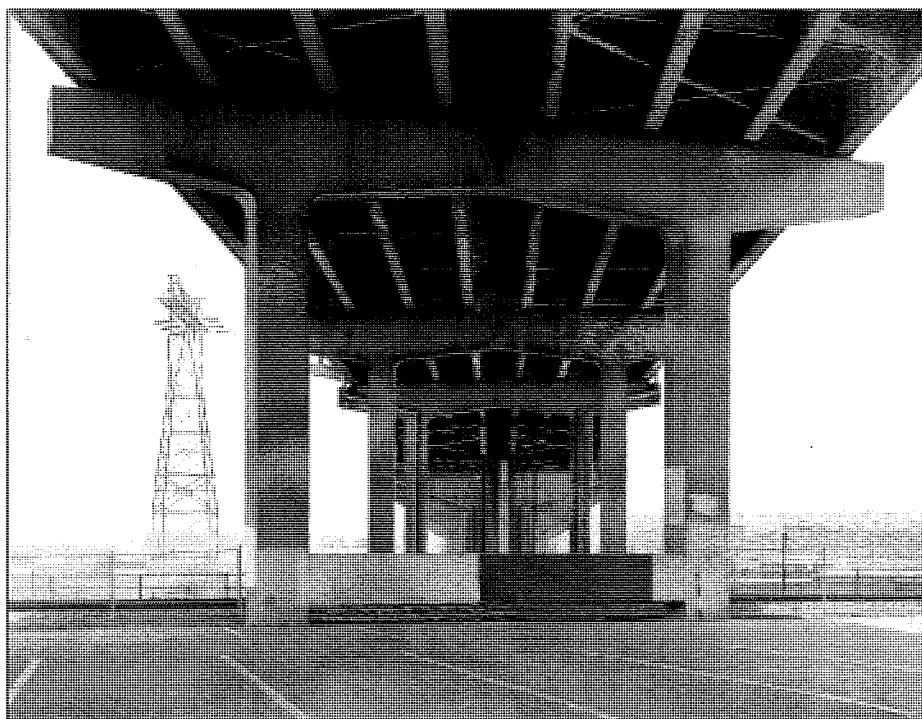
MHPR No. RA-SPC-7891-18

- RA-SPC-7891-18 VIEW OF SKEWED PIER 14 ON NORTH MARGIN OF RAILROAD RIGHT-OF-WAY, LOOKING SOUTH-SOUTHEAST FROM UNDER SPAN 15.
- RA-SPC-7891-19 VIEW SHOWING RELATIONSHIP OF PIER 14 TO DIAGONAL AND STAGGERED BEAMS IN BRIDGE DECK SYSTEM, LOOKING SOUTH-SOUTHEAST FROM UNDER SPAN 15.

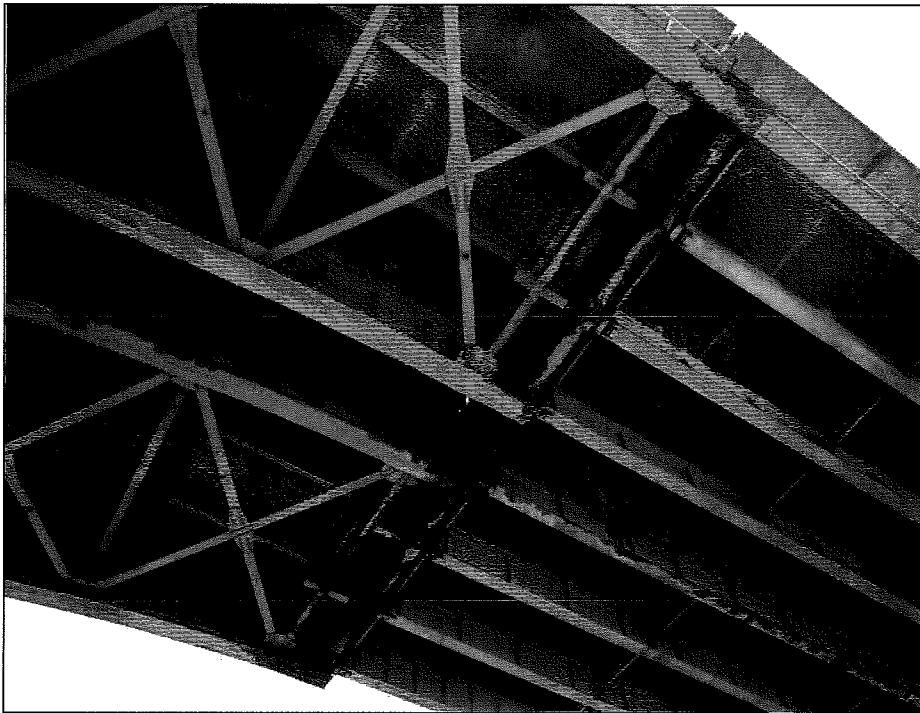
MHPR No. RA-SPC-7891-22

RA-SPC-7891-22	OBLIQUE VIEW OF HINGES AND BRIDGE DECK SYSTEM IN SPAN 12, LOOKING NORTHWEST.
RA-SPC-7891-23	DETAIL OBLIQUE VIEW OF HINGES AND BRIDGE DECK SYSTEM IN SPAN 12, LOOKING NORTHWEST.
RA-SPC-7891-24	VIEW OF HINGES AND BRIDGE DECK SYSTEM IN SPAN 12, LOOKING EAST.
RA-SPC-7891-25	VIEW OF WEST ELEVATION OF SPAN 11, LOOKING EAST.
RA-SPC-7891-26	VIEW OF SPAN 11 DECK SYSTEM, LOOKING SOUTH TO PIER 10.
RA-SPC-7891-27	VIEW OF WEST ELEVATION OF SPAN 10, LOOKING EAST FROM SOUTH BANK OF MISSISSIPPI RIVER.
RA-SPC-7891-28	OBLIQUE VIEW OF SPAN 9, LOOKING NORTHEAST FROM NEAR PIER 8.
RA-SPC-7891-29	VIEW OF SOUTHBOUND TRAFFIC AND BRIDGE DECK FROM NEAR PIER 8, LOOKING NORTHEAST.
RA-SPC-7891-30	OBLIQUE VIEW OF SOUTH ELEVATION OF PIER 8, LOOKING NORTHEAST.
RA-SPC-7891-31	VIEW OF BEARINGS ON PIER 8, STEAM UTILITY PIPE, AND SOUTH ENTRANCE TO SERVICE CATWALK, LOOKING NORTH-NORTHWEST.
RA-SPC-7891-32	VIEW OF WEST ELEVATION OF SPAN 8 HINGE AND DECK DRAINAGE SYSTEM, LOOKING EAST-NORTHEAST.

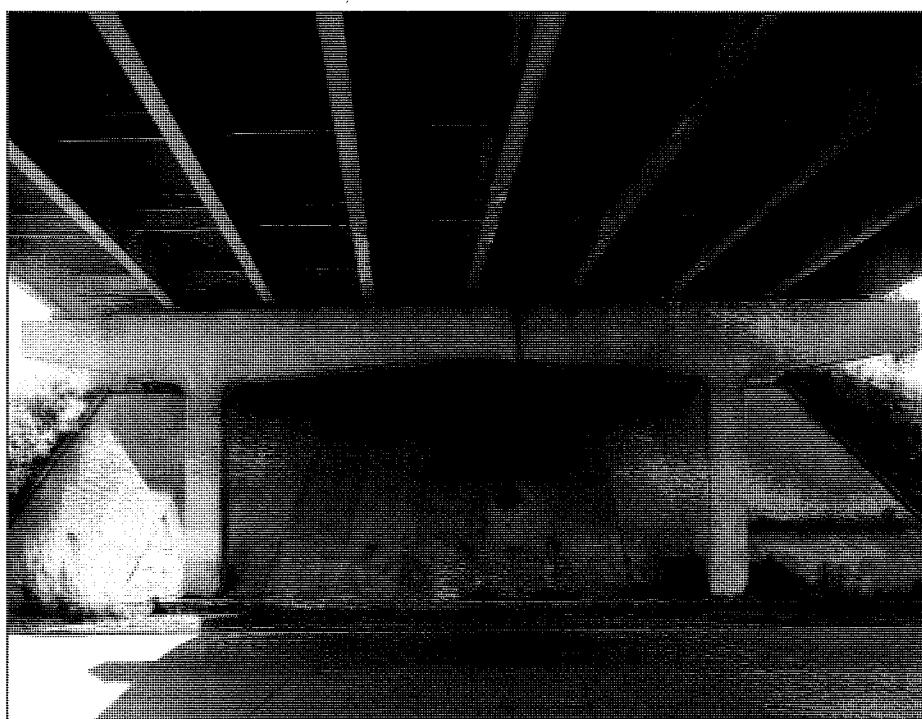
MHPR No. RA-SPC-7891-38

- RA-SPC-7891-38 VIEW OF NORTH ELEVATION OF SOUTH ABUTMENT AND PIER 1,  
LOOKING SOUTH-SOUTHEAST. FILLMORE AVENUE EAST IN  
FOREGROUND.
- RA-SPC-7891-39 VIEW OF SERVICE CATWALK BETWEEN NORTHBOUND AND  
SOUTHBOUND SPAN 10, LOOKING SOUTH-SOUTHEAST. AREA OF  
1975 GIRDER FRACTURE NEAR IMAGE MIDDLE-GROUND.

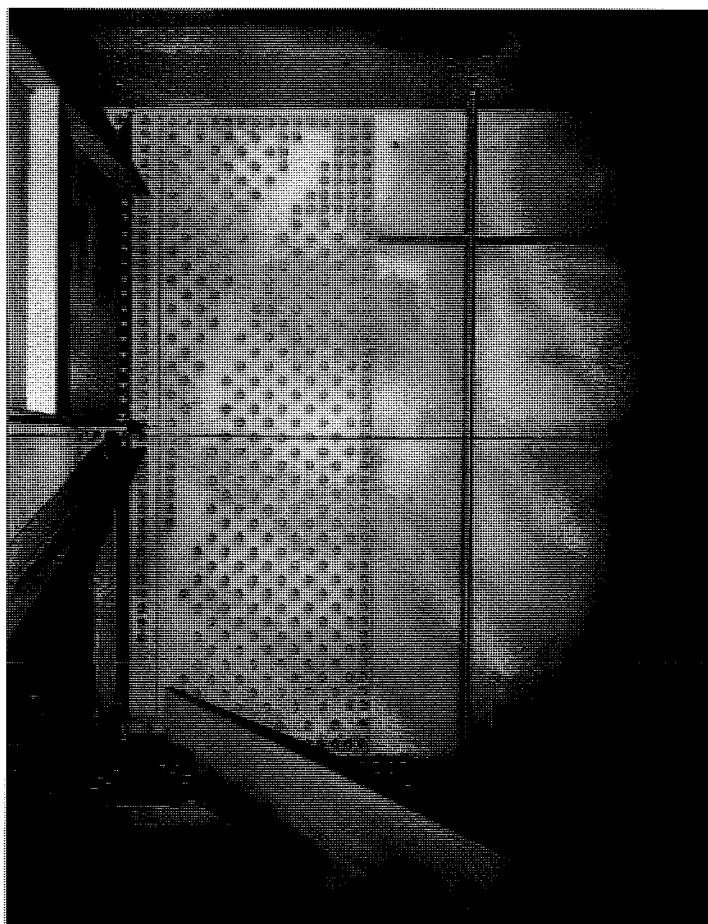
MHPR No. RA-SPC-7891-40

- RA-SPC-7891-40 VIEW OF WEST ELEVATION OF REPAIR PLATE AT 1975 GIRDER  
FRACTURE SITE, LOOKING EAST-NORTHEAST.
- RA-SPC-7891-41 VIEW OF EAST ELEVATION OF UPPER PORTION OF REPAIR PLATE  
AT 1975 GIRDER FRACTURE SITE, LOOKING WEST-SOUTHWEST.

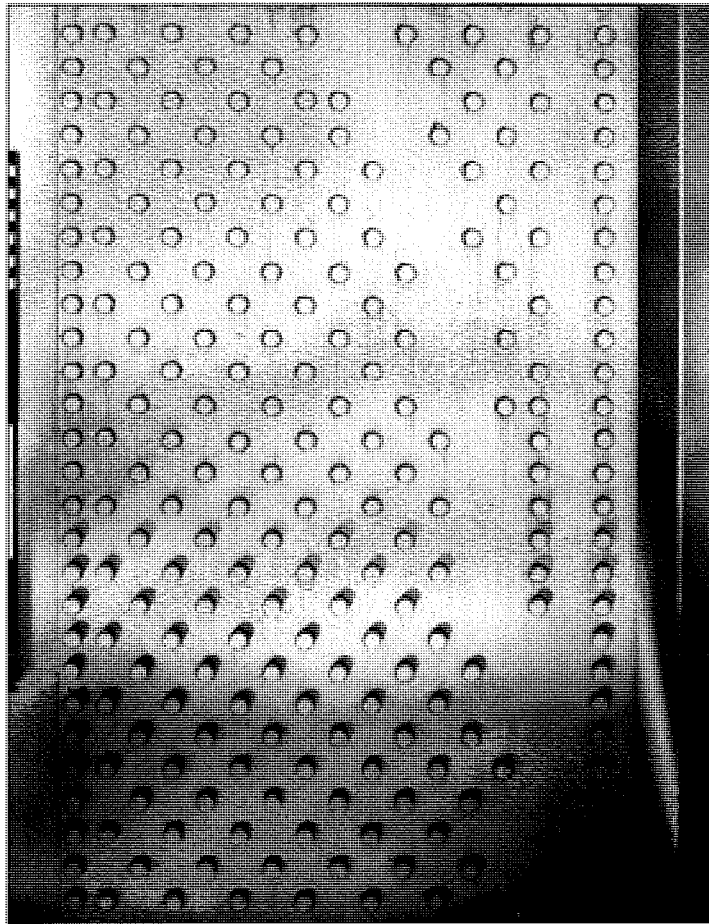
MHPR No. RA-SPC-7891-42

- RA-SPC-7891-42 VIEW OF EAST ELEVATION OF LOWER PORTION OF REPAIR  
PLATE AT 1975 GIRDER FRACTURE SITE, LOOKING WEST-  
SOUTHWEST. VIEW OF LOWEST PORTION OF REPAIR PLATE  
BLOCKED BY STEAM UTILITY PIPE.

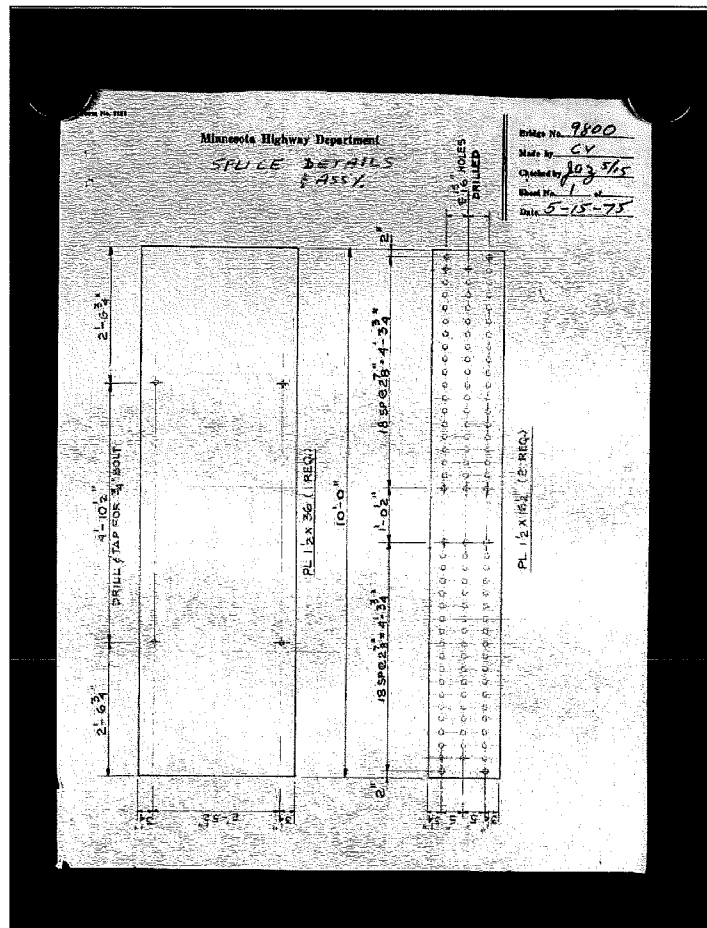
MHPR No. RA-SPC-7891-43

- RA-SPC-7891-43 FRACTURE REPAIR, HISTORICAL PLAN SHEET No. 1: SPLICE  
DETAILS AND ASSEMBLY. DATED MAY 15, 1975. BRIDGE 9088  
PROJECT RECORDS, MINNESOTA DEPARTMENT OF  
TRANSPORTATION, SAINT PAUL, MINN.

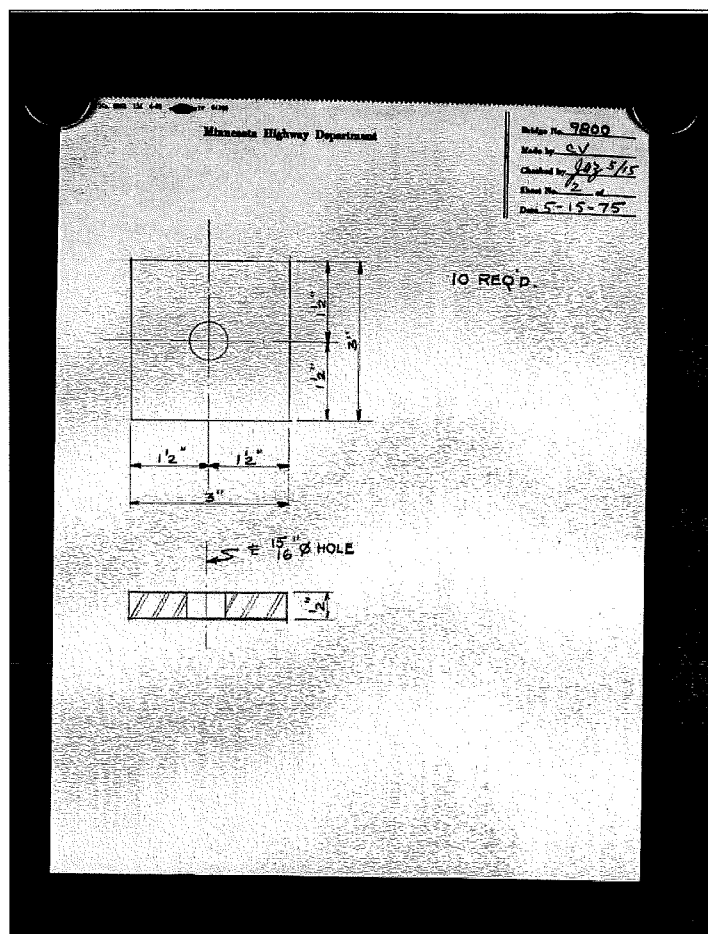
MHPR No. RA-SPC-7891-44

- RA-SPC-7891-44 FRACTURE REPAIR, HISTORICAL PLAN SHEET No. 2: UNTITLED  
DETAILS. DATED MAY 15, 1975. BRIDGE 9088 PROJECT RECORDS,  
MINNESOTA DEPARTMENT OF TRANSPORTATION, SAINT PAUL,  
MINN.

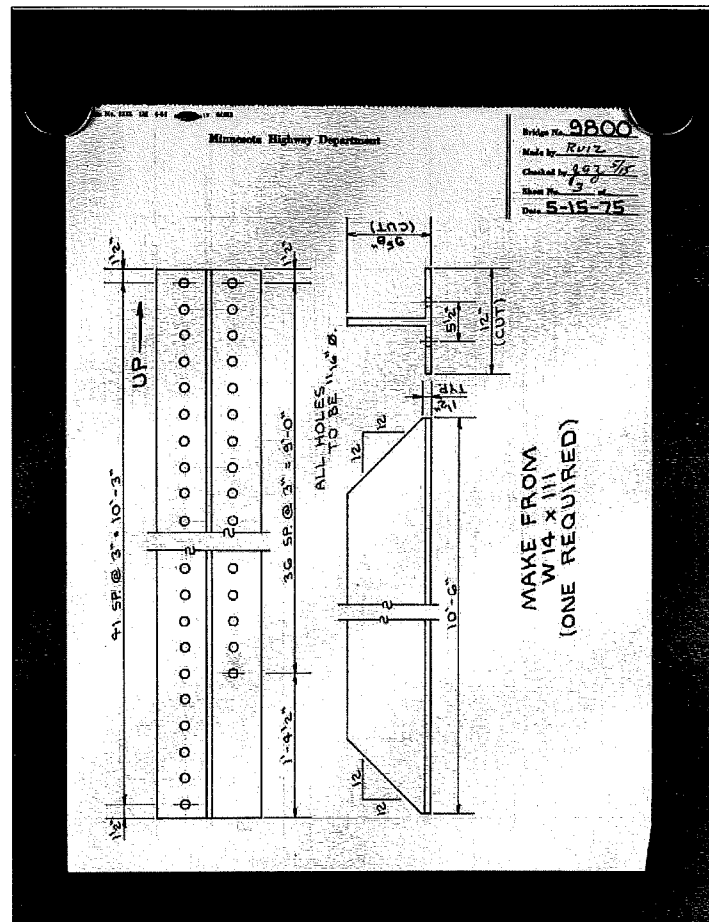
MHPR No. RA-SPC-7891-45

- RA-SPC-7891-45 FRACTURE REPAIR, HISTORICAL PLAN SHEET No. 3: UNTITLED  
DETAILS. DATED MAY 15, 1975. BRIDGE 9088 PROJECT RECORDS,  
MINNESOTA DEPARTMENT OF TRANSPORTATION, SAINT PAUL,  
MINN.

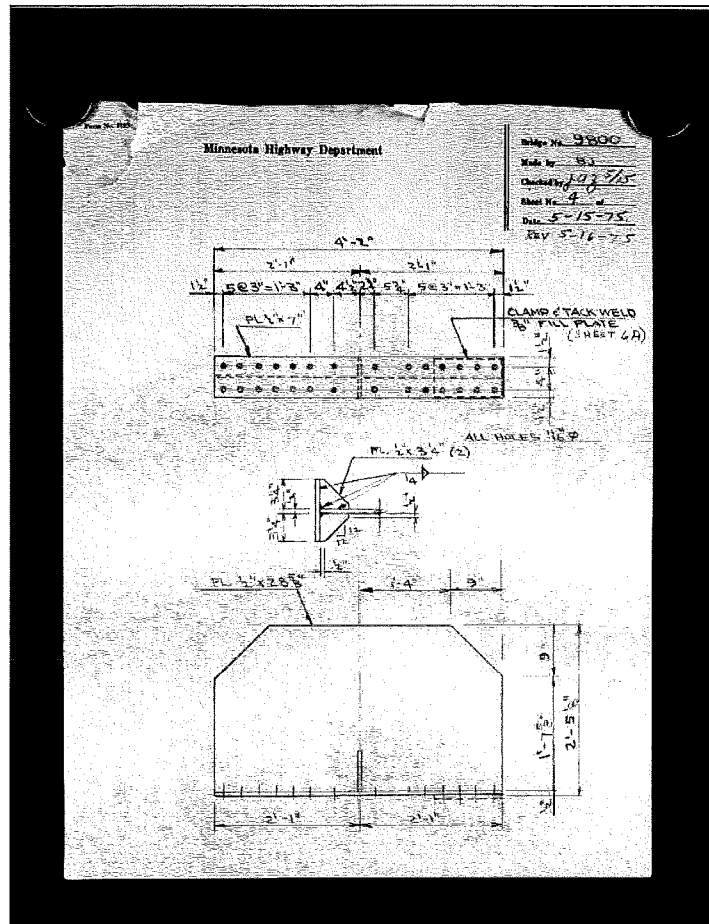
MHPR No. RA-SPC-7891-46

- RA-SPC-7891-46 FRACTURE REPAIR, HISTORICAL PLAN SHEET No. 4: UNTITLED  
DETAILS. DATED MAY 15, 1975; REVISED MAY 16, 1975. BRIDGE  
9088 PROJECT RECORDS, MINNESOTA DEPARTMENT OF  
TRANSPORTATION, SAINT PAUL, MINN.

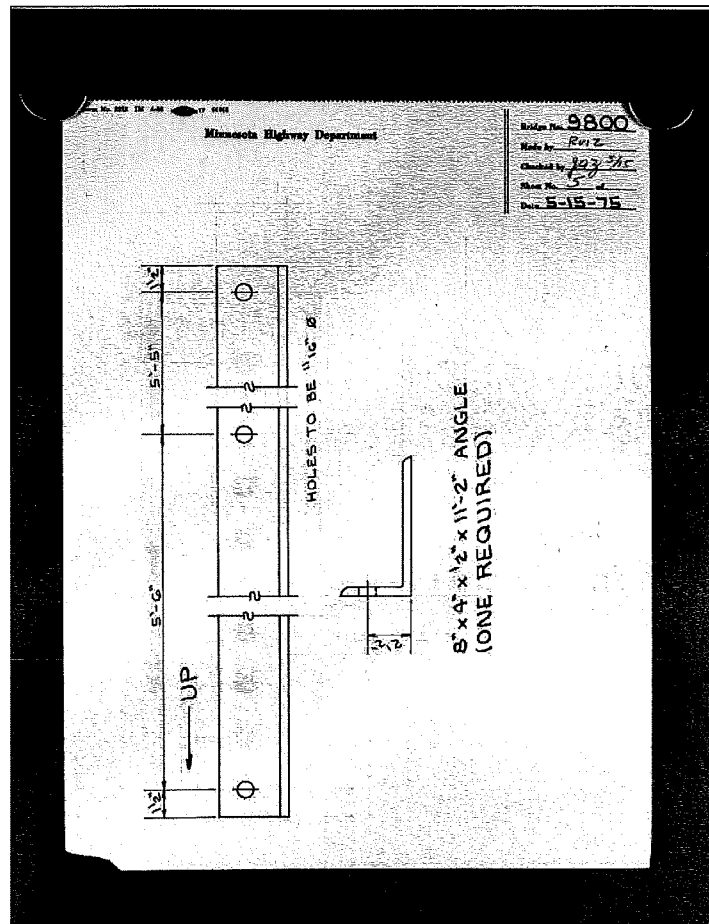
MHPR No. RA-SPC-7891-47

- RA-SPC-7891-47 FRACTURE REPAIR, HISTORICAL PLAN SHEET No. 5: 8" X 4" 1/2" X  
11'-2" ANGLE. DATED MAY 15, 1975. BRIDGE 9088 PROJECT  
RECORDS, MINNESOTA DEPARTMENT OF TRANSPORTATION,  
SAINT PAUL, MINN.

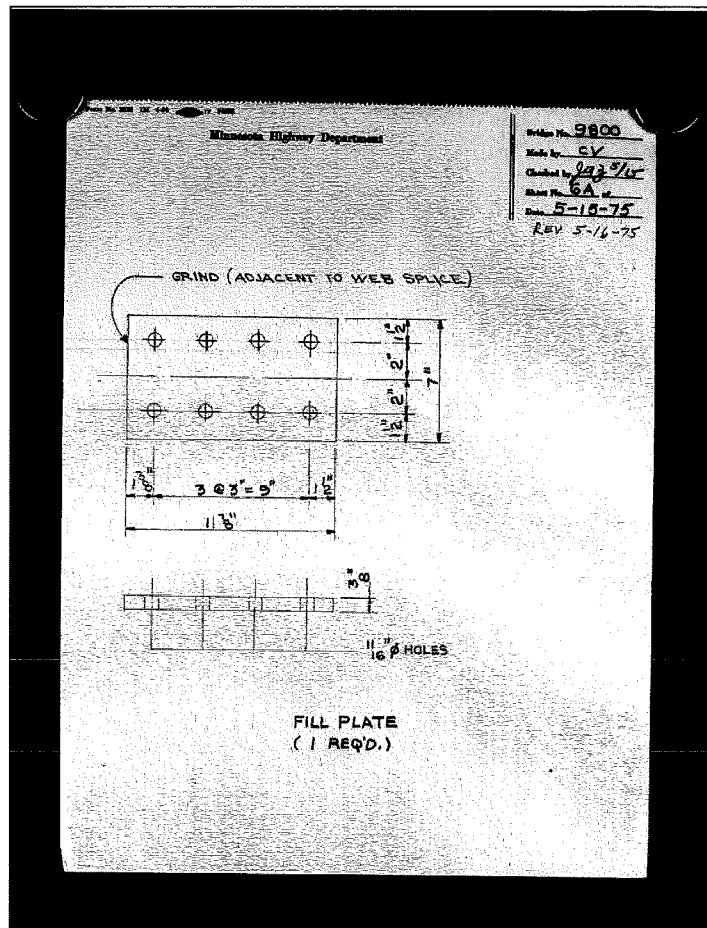
MHPR No. RA-SPC-7891-48

- RA-SPC-7891-48 FRACTURE REPAIR, HISTORICAL PLAN SHEET No. 6A: FILL PLATE.  
DATED MAY 15, 1975. REVISED MAY 16, 1975. BRIDGE 9088

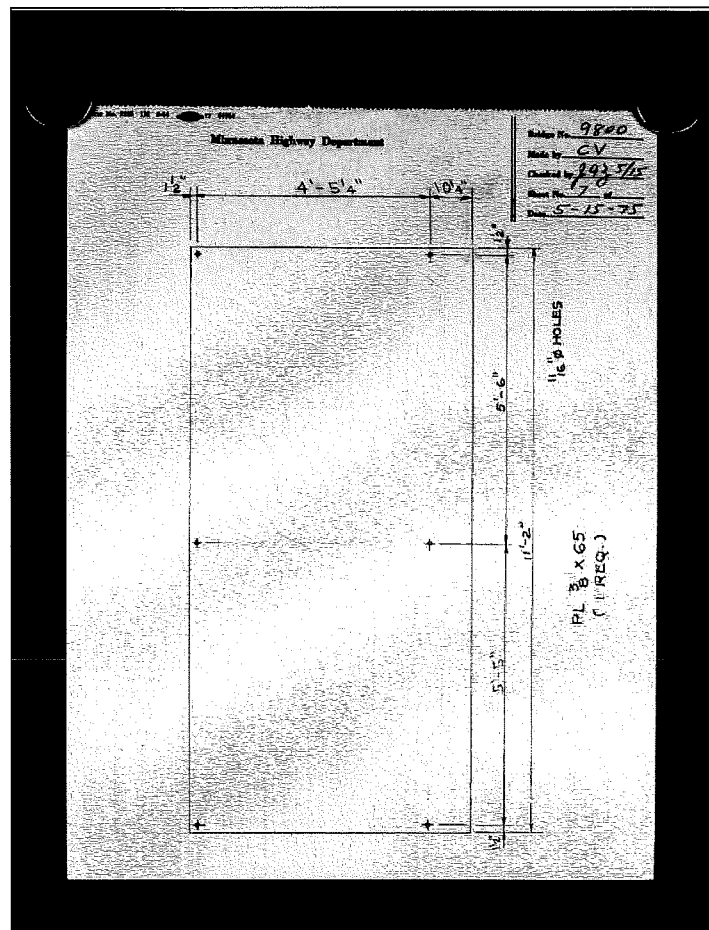
MHPR No. RA-SPC-7891-49

- RA-SPC-7891-49 FRACTURE REPAIR, HISTORICAL PLAN SHEET No. 7: PL 3/8 X 65. DATED MAY 15, 1975. BRIDGE 9088 PROJECT RECORDS, MINNESOTA DEPARTMENT OF TRANSPORTATION, SAINT PAUL, MINN.

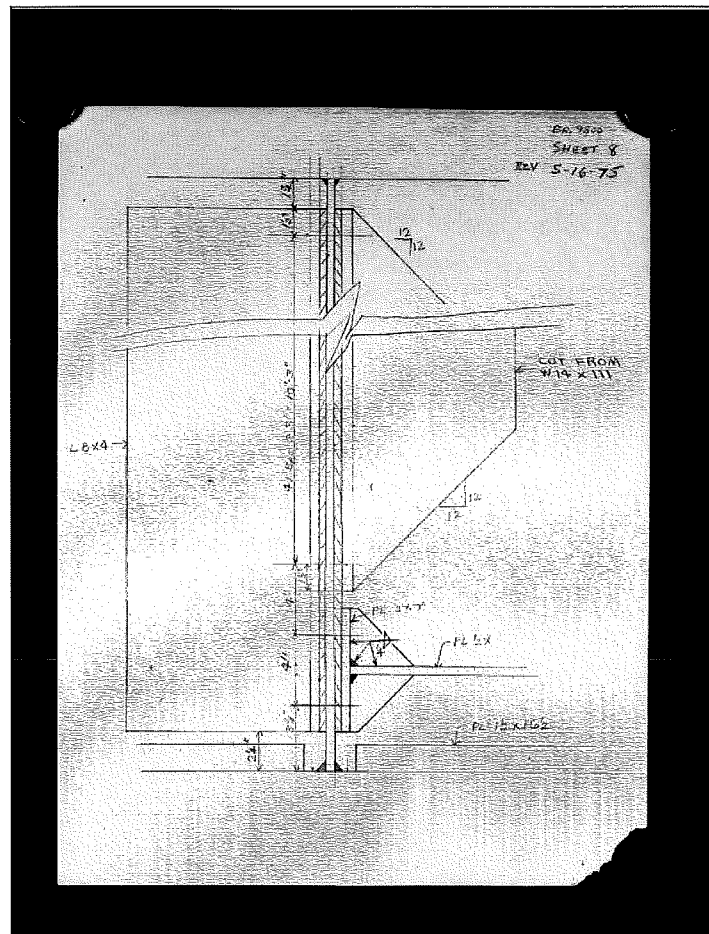
MHPR No. RA-SPC-7891-50

- RA-SPC-7891-50 FRACTURE REPAIR, HISTORICAL PLAN SHEET No. 8: UNTITLED DETAILS. REVISED MAY 16, 1975. BRIDGE 9088 PROJECT RECORDS, MINNESOTA DEPARTMENT OF TRANSPORTATION, SAINT PAUL, MINN.

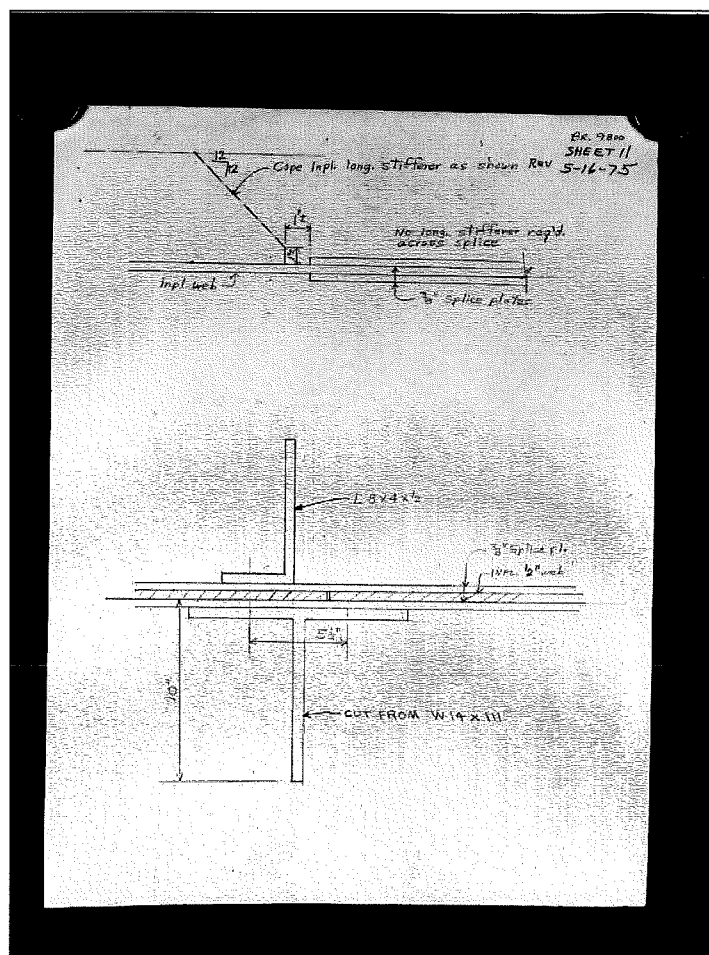
MHPR No. RA-SPC-7891-52

- RA-SPC-7891-52 FRACTURE REPAIR, HISTORICAL PLAN SHEET No. 10: UNTITLED DETAILS. REVISED MAY 16, 1975. BRIDGE 9088 PROJECT RECORDS, MINNESOTA DEPARTMENT OF TRANSPORTATION, SAINT PAUL, MINN.
